**IMPORTANT SAFETY NOTICE**  
*YOUR IMMEDIATE ACTION IS REQUIRED*

**Important Safety Notice Concerning:**

**North American NIOSH Approved Scott ELSA product - 5, 10, 15 & 5HF versions only**

**Date:** June 26, 2009

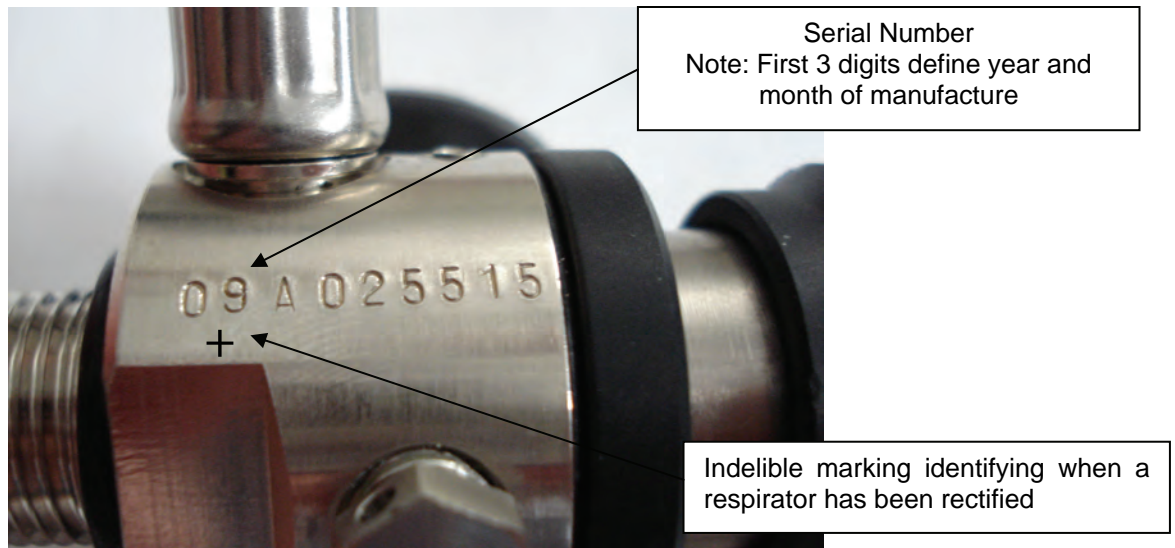
Fig. 1

Owners of these ELSA emergency escape respirators may identify the age of these products in their possession from the reducer serial number stamped into the reducer body. (see to Fig. 1, below)

The respirator serial number and date of manufacture may be determined as shown above. The first two digits of the serial number identify the year of manufacture. The third digit of the serial number represents the month of manufacture identified by the letters A-M. Note: the letter 'I' is not used to prevent confusion with the number 1.

All respirators manufactured prior to February 2009 that have been rectified to cure this leak are indelibly marked with a plus sign under the serial number as shown in Fig. 1.

Upon completion of this service your ELSA respirator will be marked with a plus sign below the serial number (see Fig. 1) to show that this upgrade has been completed.

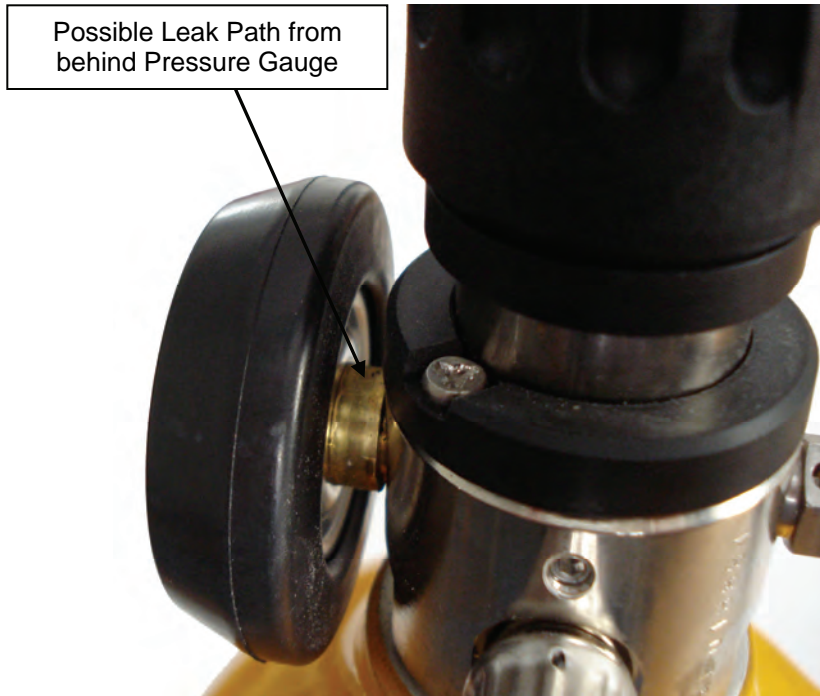
Fig. 2

The possible leak path behind the gauge is highlighted on Fig. 2. The potential leak path between the charging port adaptor and the reducer body is highlighted on Fig. 3.

Scott has taken action to address both of these problems: From February 2008 the material of the O-ring behind the gauge has been changed from Nitrile to Viton<sup>®2</sup> to improve the sealing of the joint. From February 2009 additional thread adhesive has been applied to the threaded joint between the reducer body and the charging port adaptor to ensure continued tightness of the adaptor after charging.

Your Scott Authorized Service Center will replace the cylinder valve gauge O-ring to prevent risk of leakage from behind the gauge. The service center will also replace the bonded seal and add thread adhesive to the CGA connector to prevent leakage from this connector.

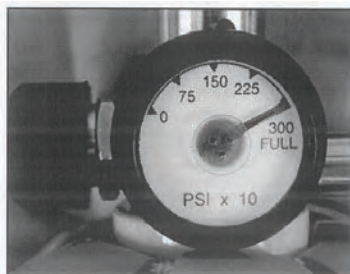
Fig. 4

- Regular Operational Inspection Step 9, below:  
“Ensure cylinder is fully charged. At room temperature the tip of the gauge pointer must be touching any part of the full band. See Fig. 4. If the cylinder is not full remove from service and tag for refilling by authorized personnel. See Cylinder Charging Procedure section of this instruction.”

During this routine inspection, take note of the date of manufacture and determine if there is any drop in cylinder pressure during storage of the respirator. If a pressure drop is noted, remove the respirator from service and return it to your local Scott Authorized Service Center for appropriate corrective actions.
